Technical Report No. 2

Air Force Office of Scientific Research

MECHANISMS OF CORROSION FATIGUE IN HIGH STRENGTH
I/M AND P/M ALUMINUM ALLOYS

4. TITLE (and Subtitle) MECHANISMS OF CORROSION FATIGUE IN HIGH STRENGTH I/M AND P/M ALUMINUM ALLOYS		5. TYPE OF REPORT & PERIOD COVERED 1 Technical
		6. PERFORMING ORG. REPORT NUMBER Technical Report No. 2

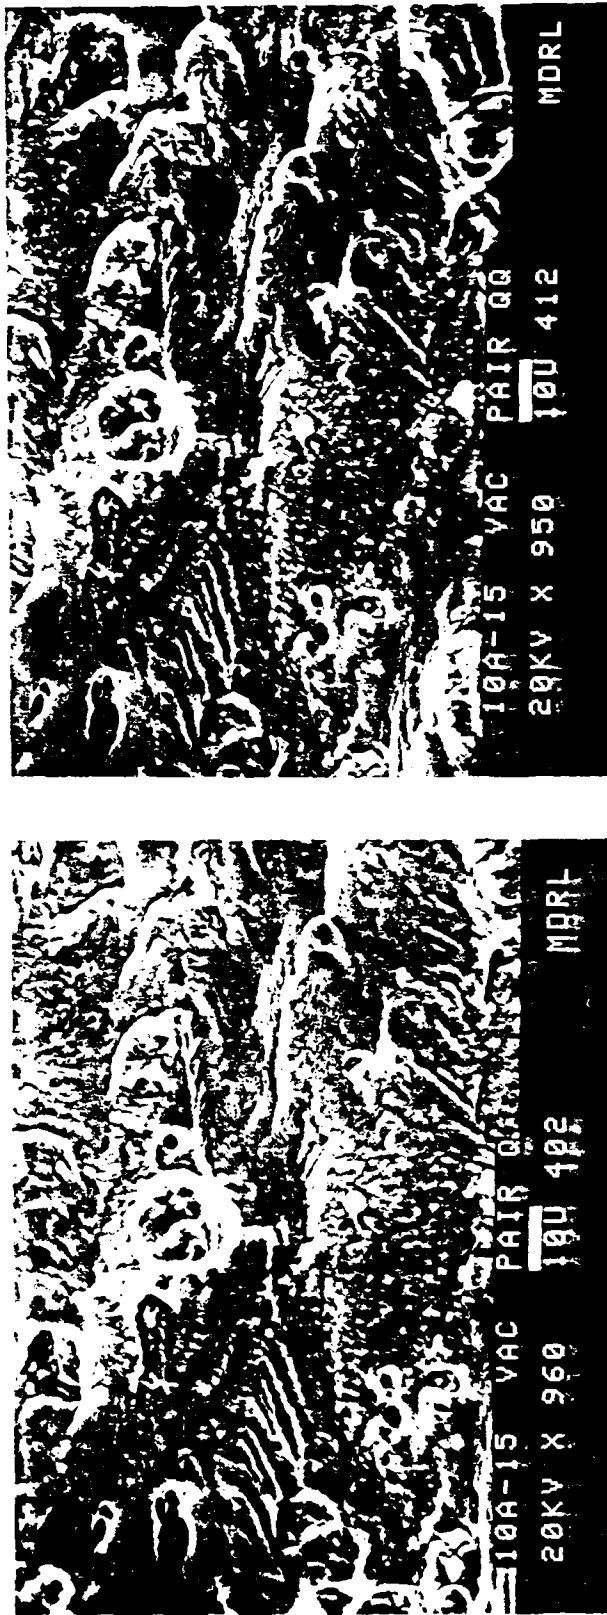
Fig. 20: Stereo pair of the fracture surface morphology for 7075-T651 tested in vacuum. The stereo pair of the mating half is shown in Fig. 19.

A close match between mating surfaces is seen. Holes on one surface are closely matched to particles or protrusions on the other surface. Every ridge on the one surface has a corresponding valley on the other. This correspondence indicates the "brittle nature" of fatigue cracking in 7075-T651 as compared to the more "ductile", void coalescence mode found in over-load

fracture; where ridges correspond to ridges, and valleys to valleys. Slip steps are more pronounced on one surface than the other (Figs. 18 to 20). The implications of these observations are not clear and are being examined.

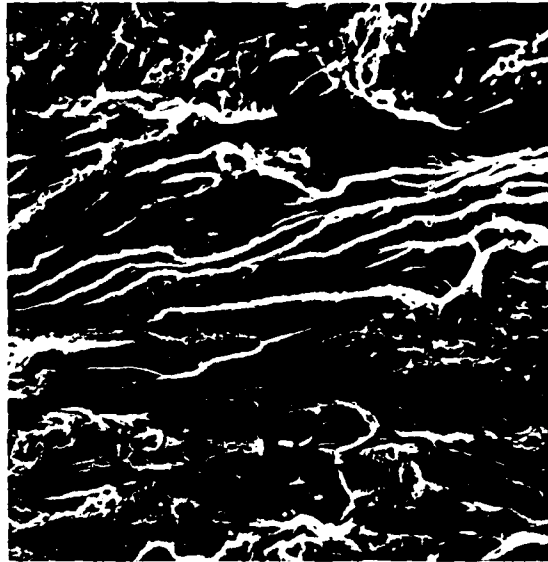
Fig. 25: SEM microfractographs of I/M 7075-T651 specimen tested in water vapor at 4.7 Pa ($\Delta K = 11 \text{ MPa}\sqrt{\text{m}}$, $f = 5 \text{ Hz}$, and $R = 0.1$). a) 300 X, b) 600 X, showing corrosion fatigue component, and c) 600 X, showing mechanical component.

Representative scanning electron (SEM) microfractographs taken from specimens tested in vacuum, pure oxygen and pure water vapor are shown in Figs. 17 to 28. Fractographs and stereo pairs from mating fracture surfaces were obtained to provide more detailed information on the fracture processes (see Figs. 18, 19, 20, 22, 27 and 28). Because the effect of water vapor pressure on fracture surface morphology is of special interest, particularly in the low pressure region where the crack growth rates are controlled by gas transport, microfractographs representing five different water vapor pressures (that is, 1.3, 2.7, 4.6, 67, and 670 Pa) have been included (see Figs. 23 to 26).

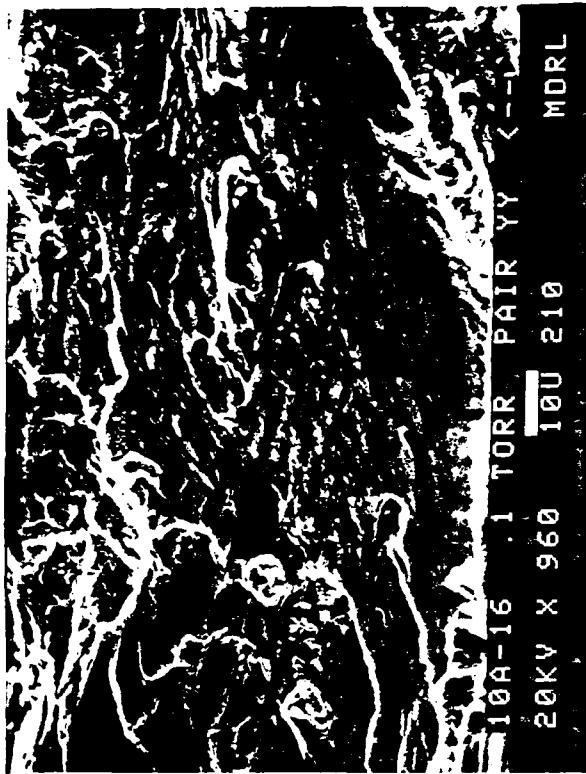
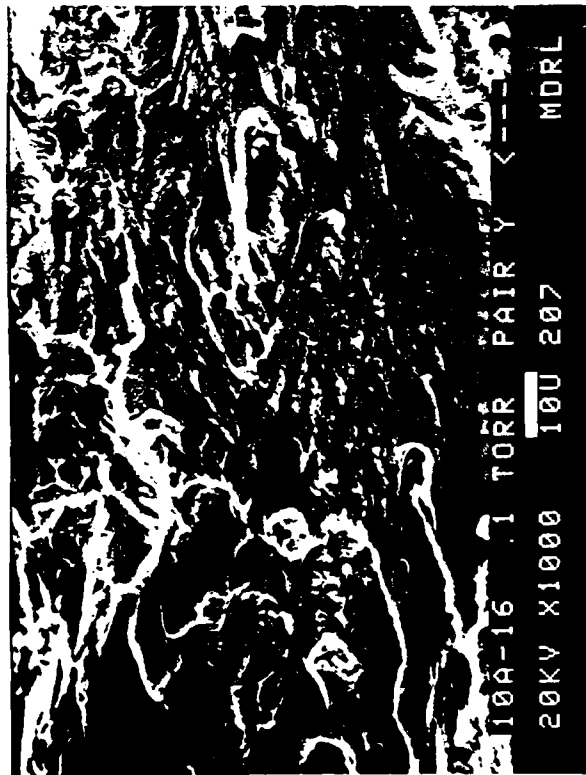
Fig. 27: Stereo pair of the fracture surface morphology for 7075-T651 tested in 13.3 Pa water vapor. The stereo pair of the mating half is shown in Fig. 15.
